# Manhole Inspection Summary

Manhole # S41K\_\_025MH

Insp Date: **5/23/08 9:09 AM**

**Location** Address: **921 eastern ave**

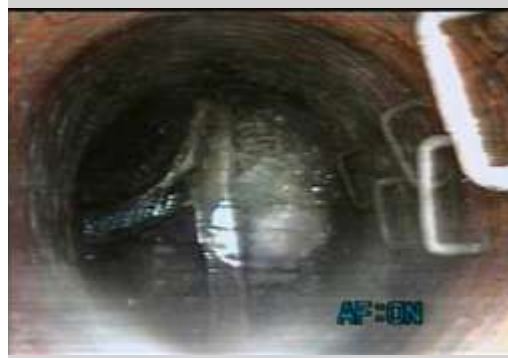
Top View

top view & steps

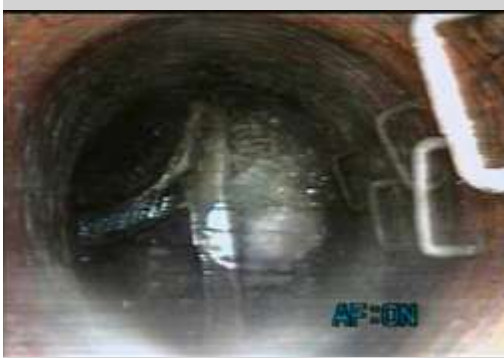
Defect 1

Condition: ☐ Sound ☐ Cracked ☐ Root Intrusion ☐ Deteriorated ☐ Leaks ☒ **Debris**

Count: **5** Missing: **0** ☒ **Corroded**

corroded steps; channel & bench debris

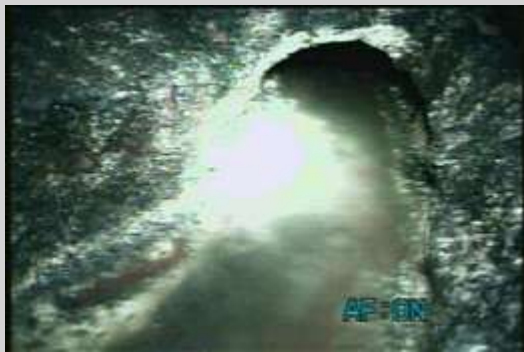
12 O'Clock Outflow

8 in. Circular Gravity Sewer  
Pipe Out @ 12 O'Clock

Deposits: ☐ None ☐ Mud ☐ Sludge ☐ Debris ☒ **Grease**

Silt Depth: 0 (in.) Deposits Extent: **Light**

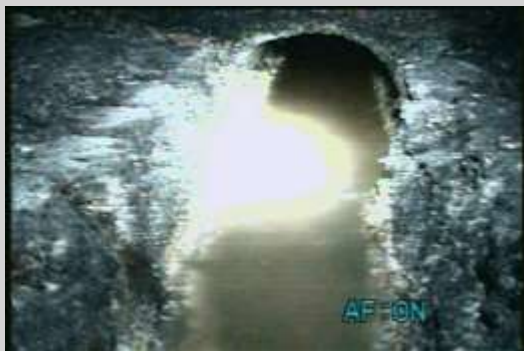
6 O'Clock Inflow

8 in. Circular Gravity Sewer  
Pipe In @ 6 O'Clock

Deposits: ☐ None ☐ Mud ☐ Sludge ☐ Debris ☒ **Grease**

Silt Depth: 0 (in.) Deposits Extent: **Heavy**

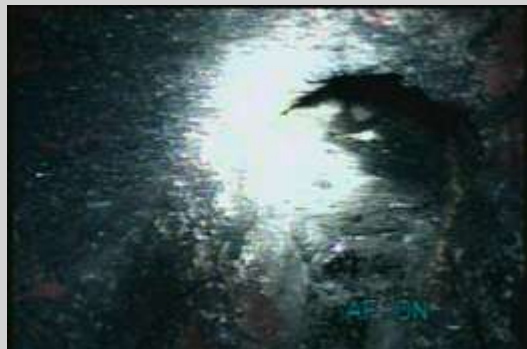
9 O'Clock Inflow

8 in. Circular Gravity Sewer

Pipe In @ 9 O'Clock

Deposits: ☐ None ☐ Mud ☐ Sludge ☐ Debris ☒ **Grease**

Silt Depth: **0** (in.) Deposits Extent: **Light**
